Intel[®] Core[™]2 Extreme Processor QX9000^Δ Series and Intel[®] Core[™]2 Quad Processor Q9000^Δ, Q9000S^Δ, Q8000^Δ and Q8000S^Δ Series

Specification Update

— on 45 nm Process in the 775-land LGA Package

December 2010

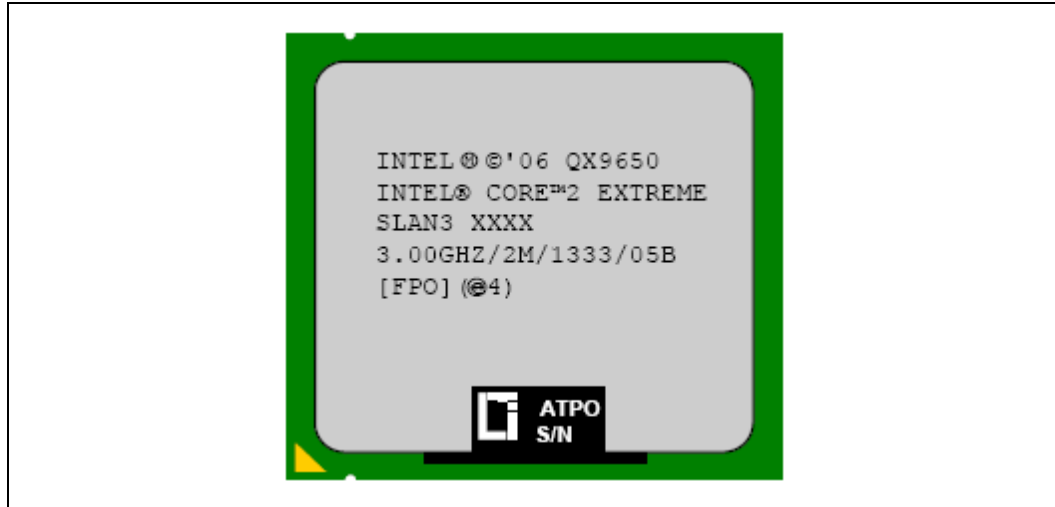
Figure 1. Processor Top-Side Markings Example (Intel® Core™2 Extreme Processor QX9650)

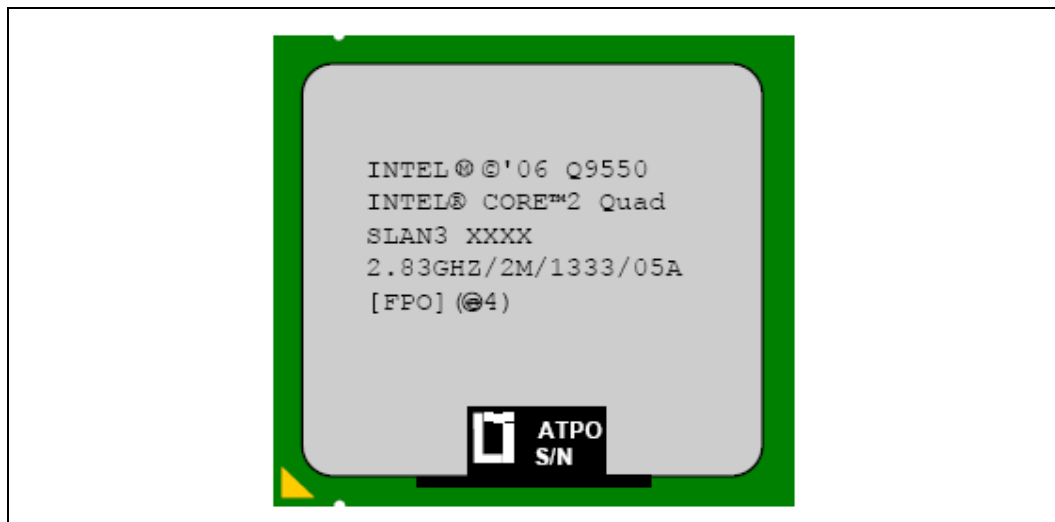
Figure 2. Processor Top-Side Markings Example (Intel® Core™2 Quad Processor Q9000 Series)
